**EXPERIMENTAL MAINTENANCE PAINTING
ON THE I-64 RIVERSIDE EXPRESSWAY
IN LOUISVILLE**

**Research Report
KTC-00-10**

June 2000

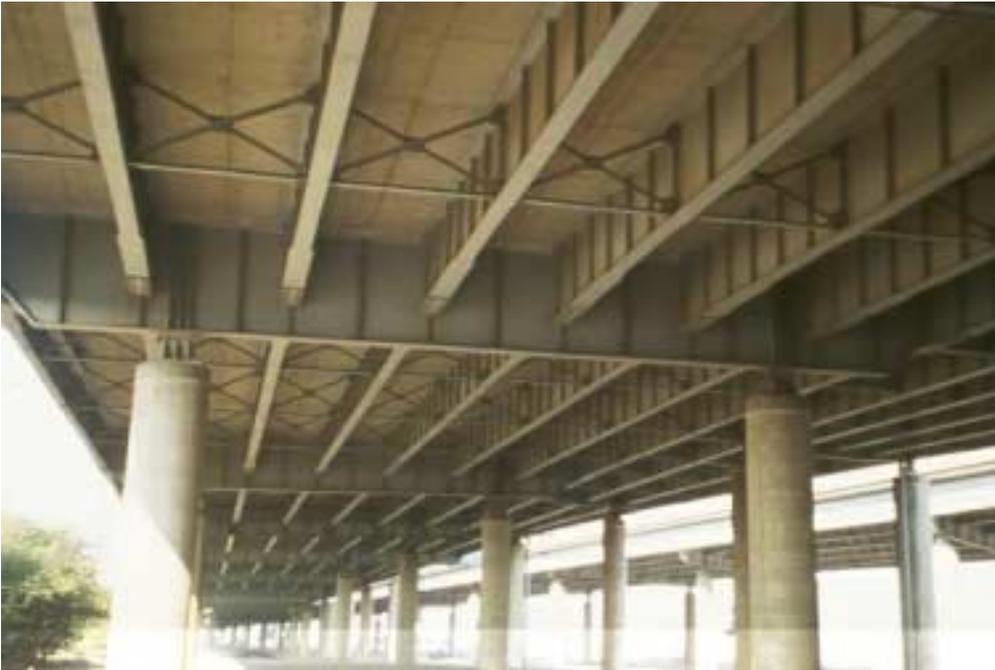
The condition of the existing paint varied significantly throughout the project. On most of the spans, the paint was in good condition with a slight amount of rust, usually observed in the bearing areas (Figures 1, 2). Structures on spans at the east end of the Parkway had pin-and-hanger connections with open deck joints. Floor beams under those joints had extensive corrosion around the lower flanges (Figure 3). Otherwise, the paint on those spans was in good condition. On a short section of span 9, the aluminum topcoats were disbonding from the primer (Figure 4). Span 13 appeared to possess some incipient rust bloom on many of its structural elements (Figure 5). The paint on span 14 was disbonding extensively throughout its structures with some rust evident on the exposed mill scale (Figure 6).

Figure 1. The existing coating on span 2 in 1995.

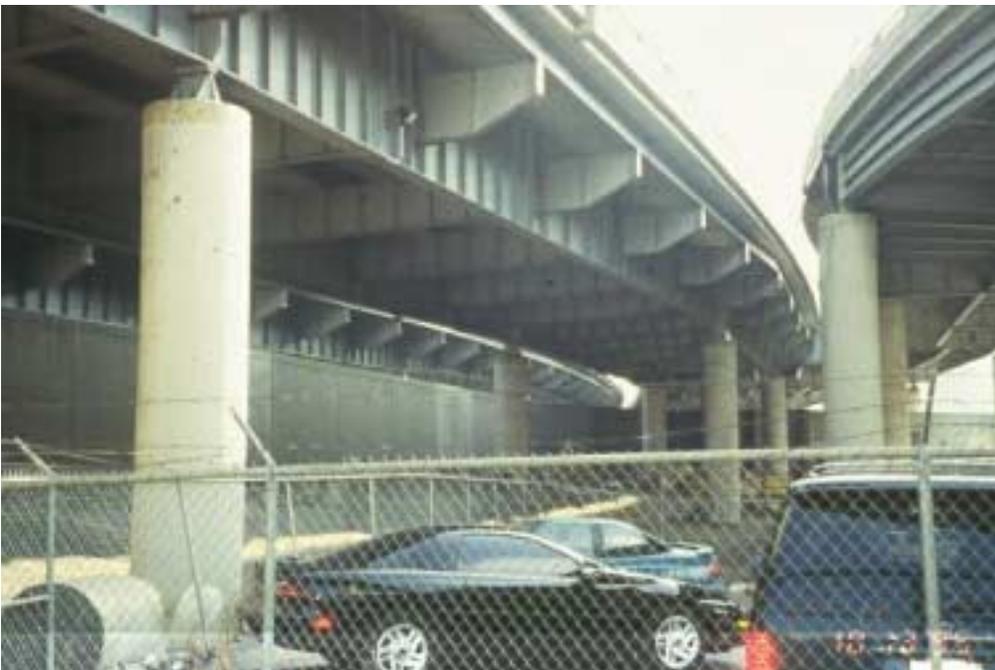
Figure 2. The existing coating on span 3 in 1995.

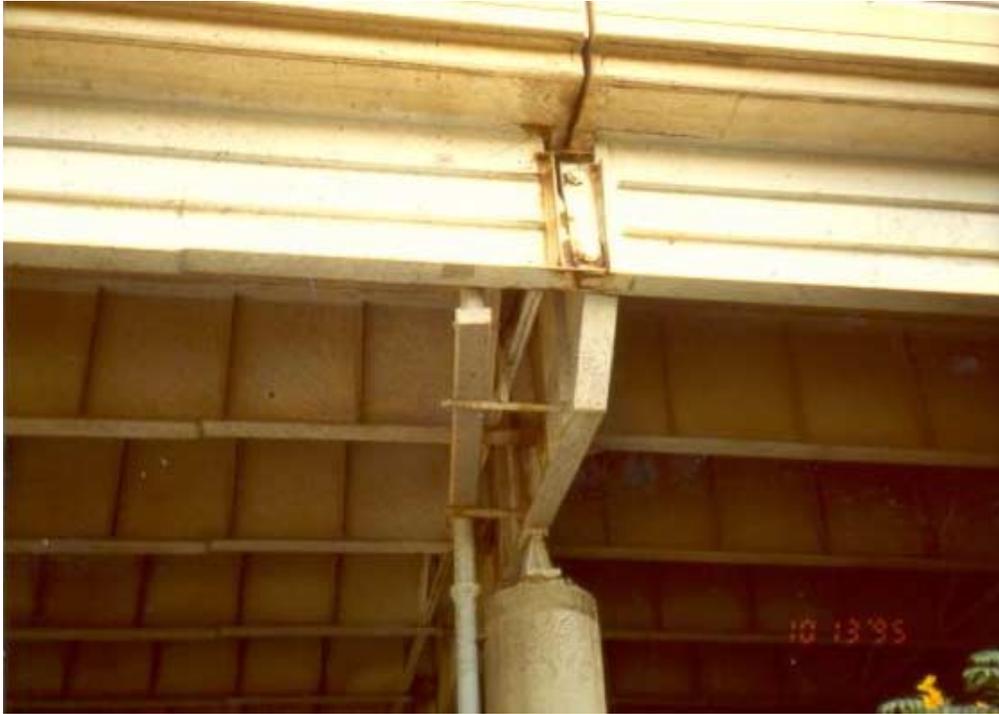
Figure 3. Corrosion at an open deck joint in span 1 in 1995.

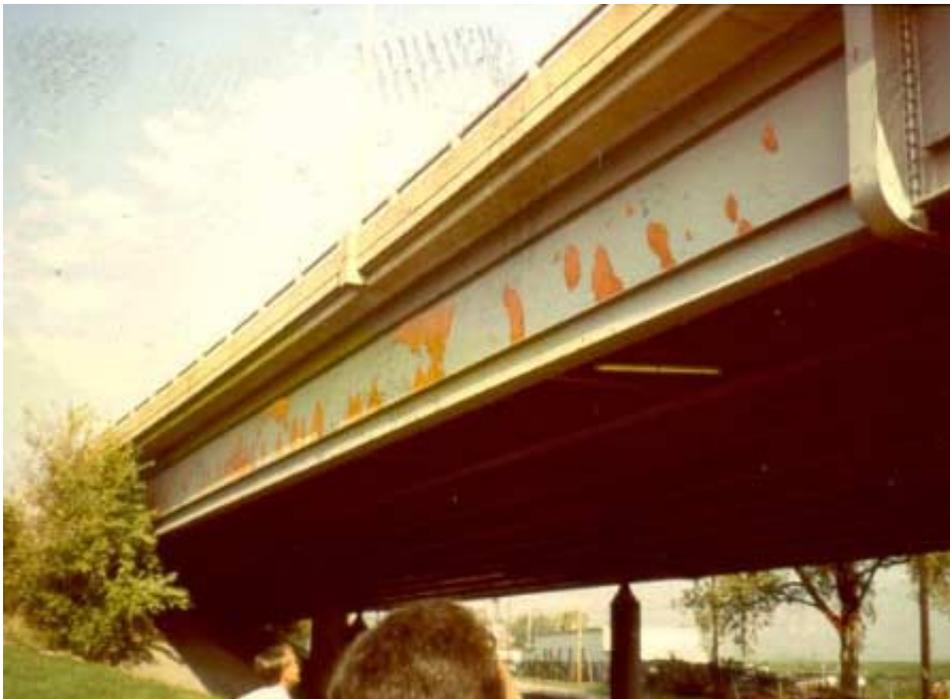
Figure 4. Existing aluminum alkyd disbonding on span 9 in 1995.

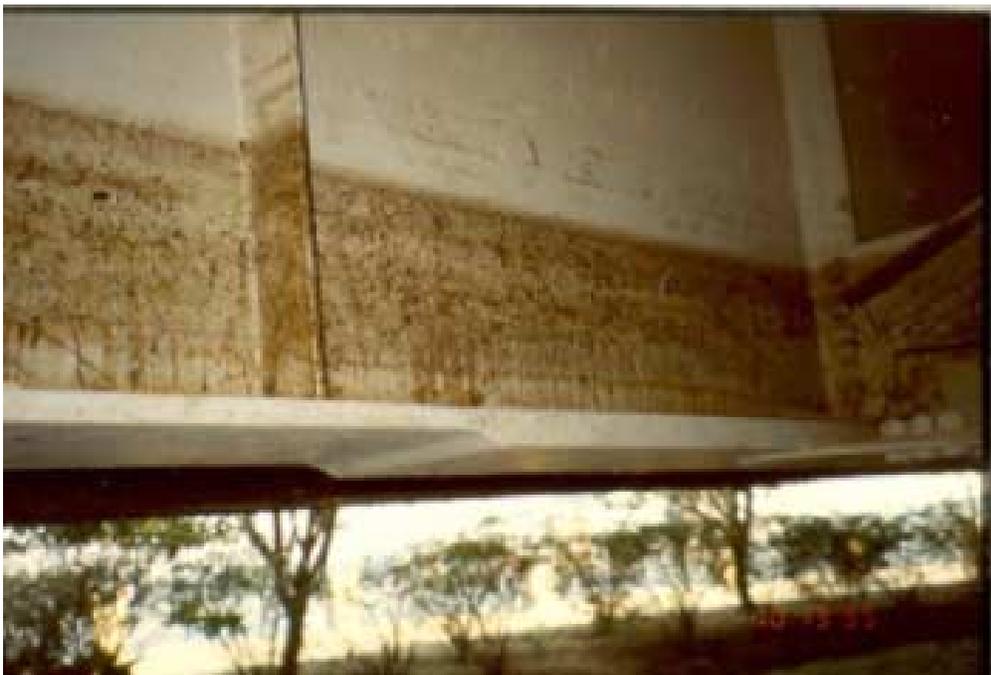
Figure 8. Oil deposits on the 3rd Street off ramp.

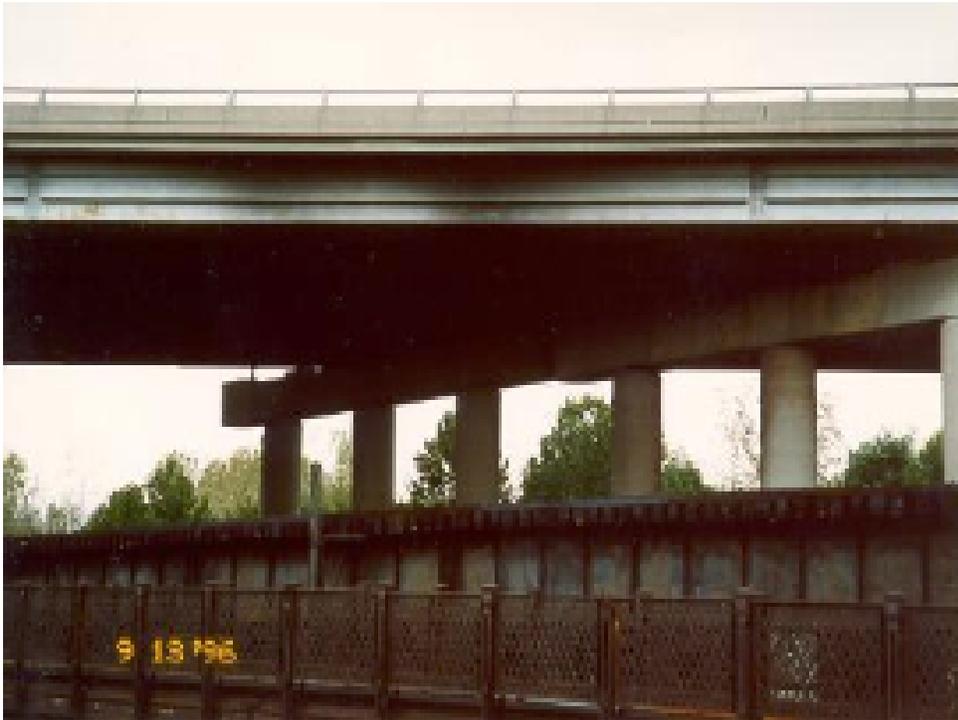
Figure 9. Diesel fumes on span 13 railroad overpass.

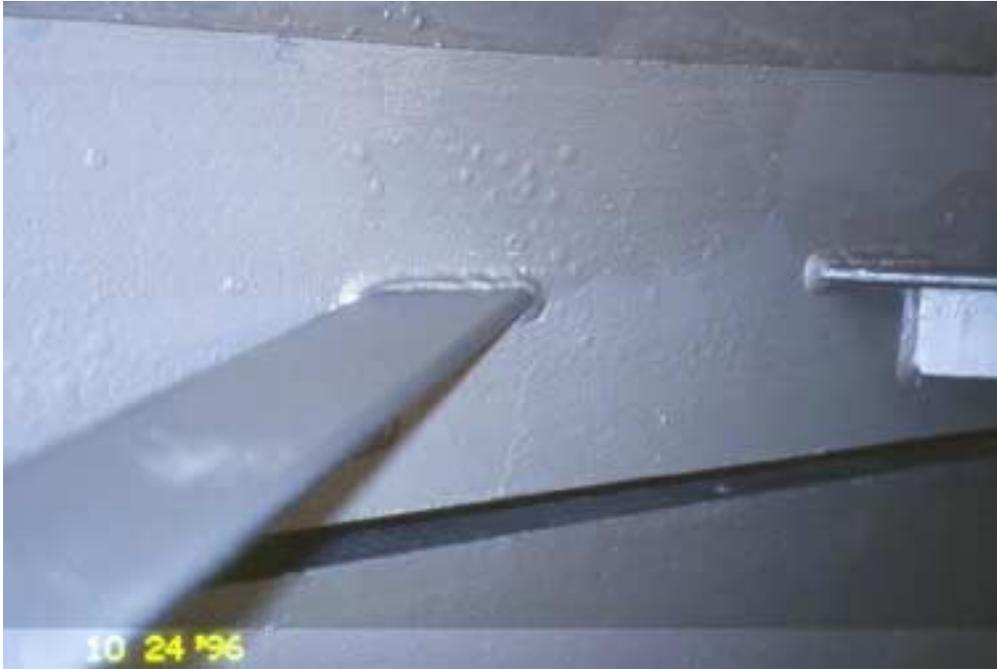
The contractor began work on the project in September 1996. When colder temperatures were encountered in October, the contractor experienced a problem with paint blistering in the MCU primer. Short-term attempts to remedy the problem were unsuccessful and project was halted for the winter. During that time, KYTC, KTC and the paint manufacturer worked to resolve the blistering problem. Some 20 different paint formulations were applied under similar conditions to those resulting in blistering. A solution to the problem was identified, and after the contractor resumed his work in April 1997, the revised MCU primer performed properly.

Figure 15. Blistering encountered in MCU aluminum primer in 1996.

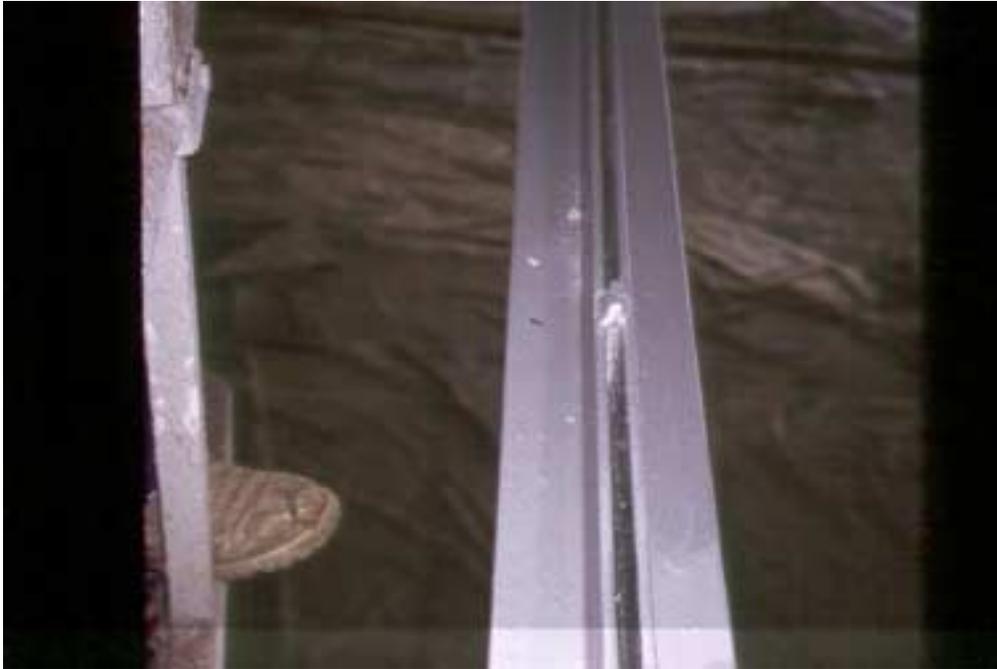
Figure 21. Back-to-back angles that posed both cleaning and painting problems in span 13.

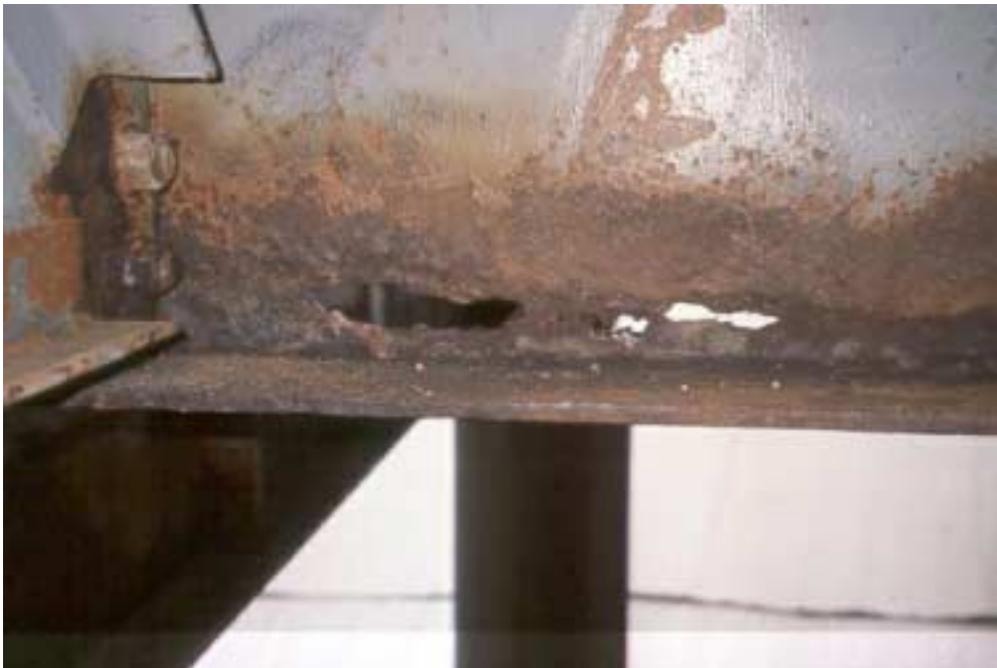
Figure 28. Severe corrosion damage to floor beam under open deck joint in span 1.

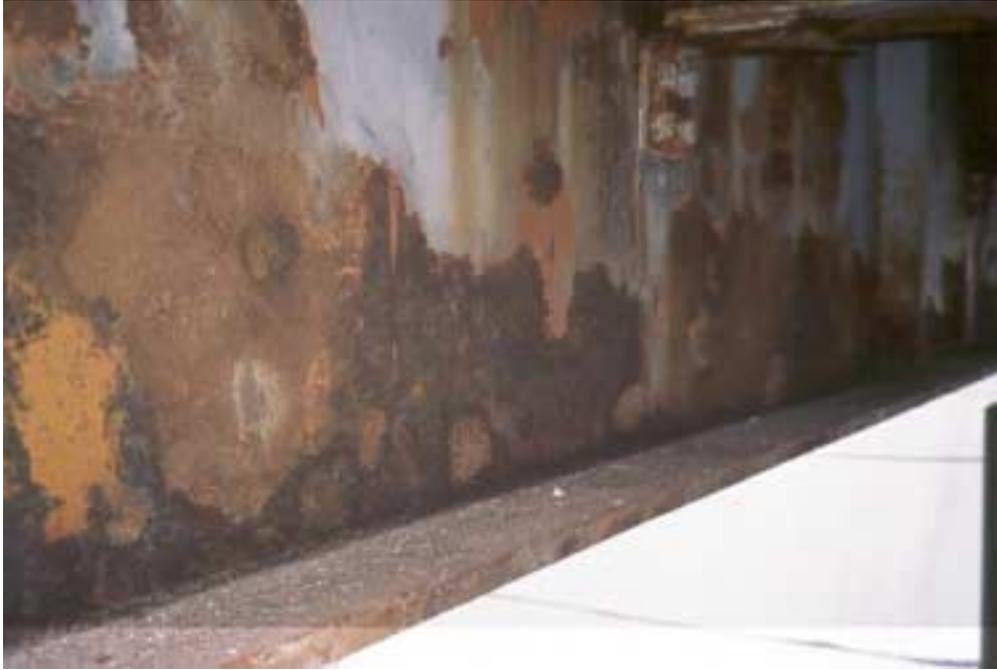
Figure 29. Floor beam in span 1 after powertool cleaning.

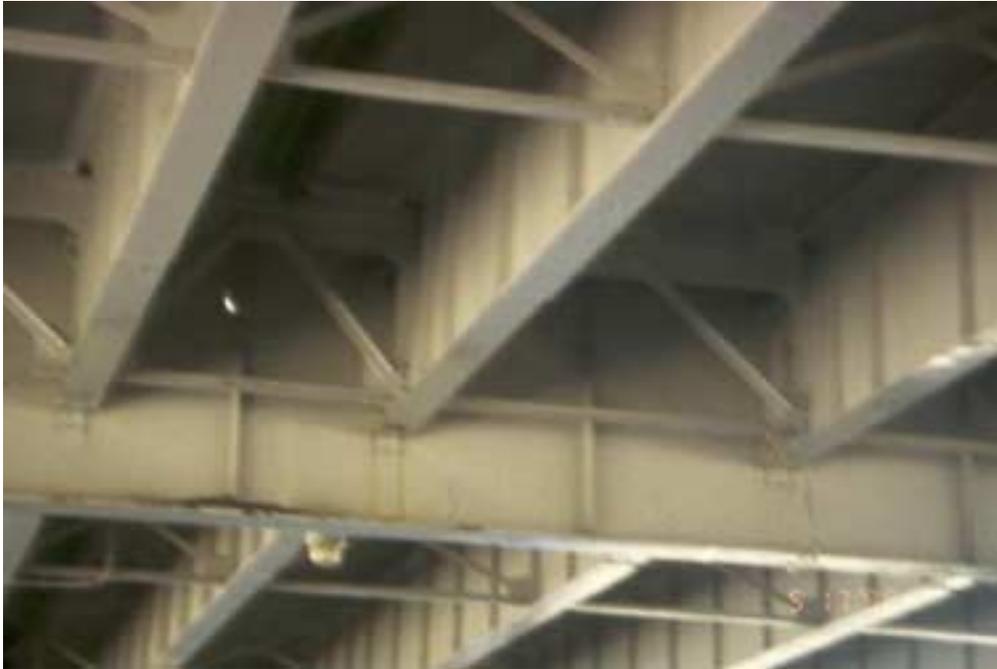
Figure 49. Debris build-up under open joints in span 1 observed in 1998.

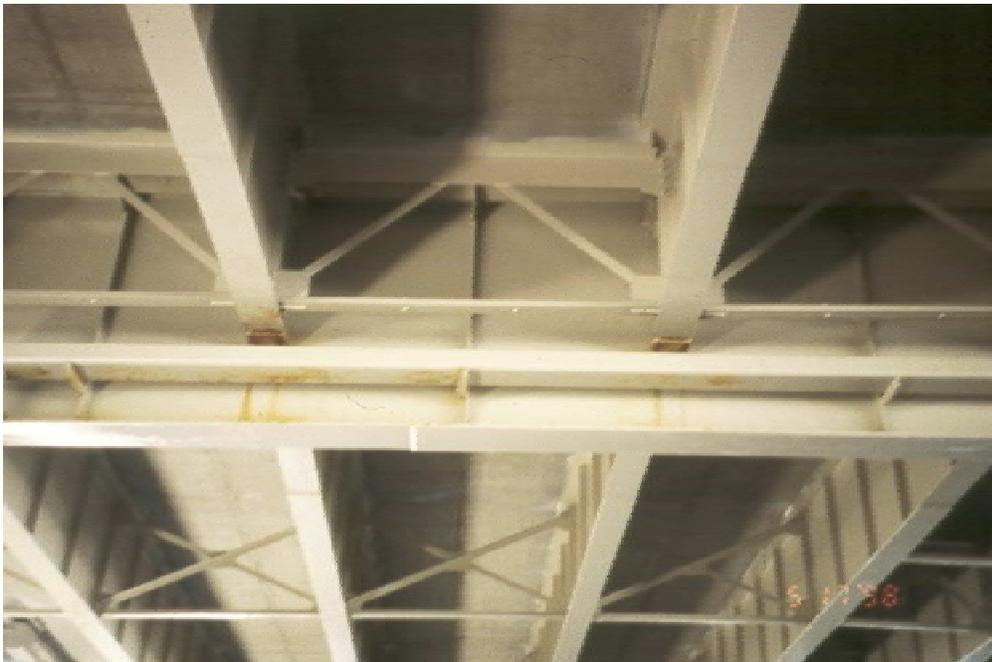
Figure 50. Slight corrosion and rust staining under open deck joint in span 1 observed in 1998.

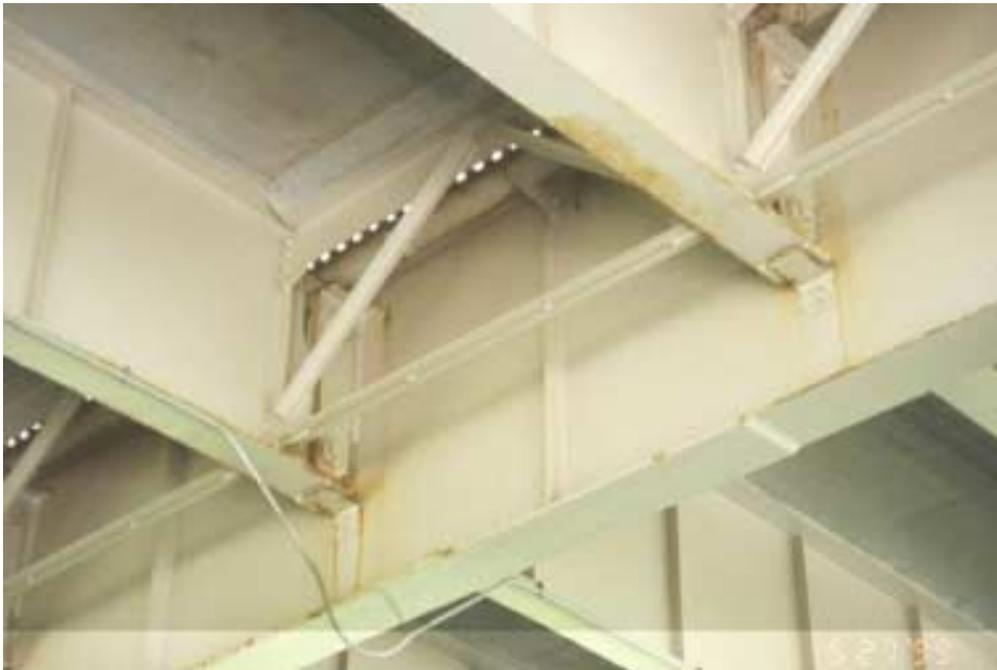
Minor rust was identified at bearings and below deck joints. More obvious stains from rusting in the deck joints were present on the overcoated steel below deck joints. To a casual observer these stains appear to be rusted areas in the paintwork. There was slight construction damage in the form of chipped or scuffed paint at several areas on Span 1. The damage occurred after the overcoating was completed and accepted.

Troughs under the open deck joints were not sized sufficiently wide. Stains on the overcoated steel indicate that the troughs have overflowed. Debris build-up on some flanges under the deck joints indicated that the drains also might have become clogged from material falling through the open deck joints. Some overspray of paint was observed on pier columns where the contractor sprayed the drainpipes. Conduit on a column near 2nd Street was primed but topcoat was not applied.

Figure 52. Corrosion and rust staining under a finger dam/trough assembly in span 1.

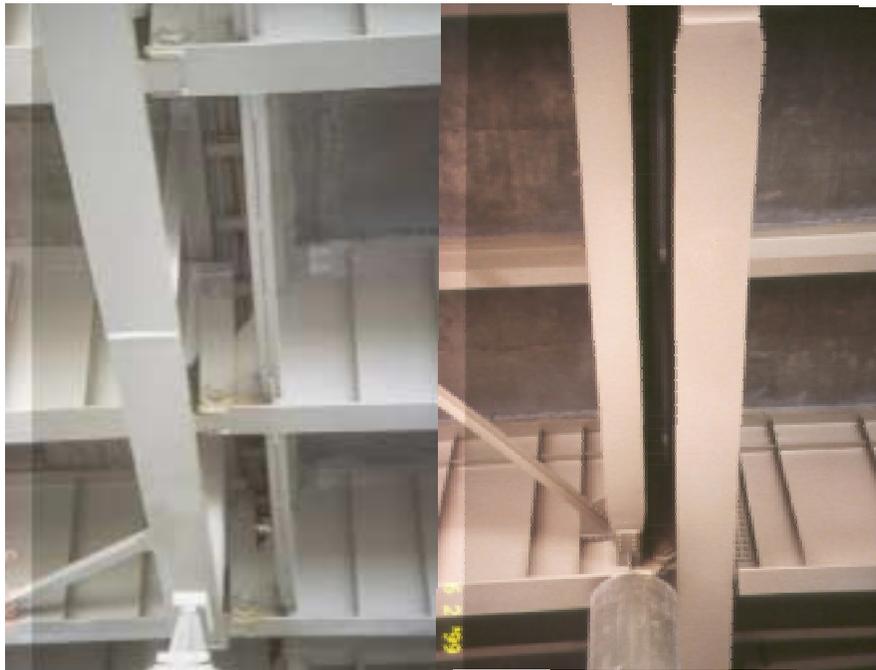
Figure 55. Large and small modular joints in span 2 showing much less corrosion than the open finger joints on spans 1 and 2 in 1999. Note that lighting impacts the apparent color of the coatings.

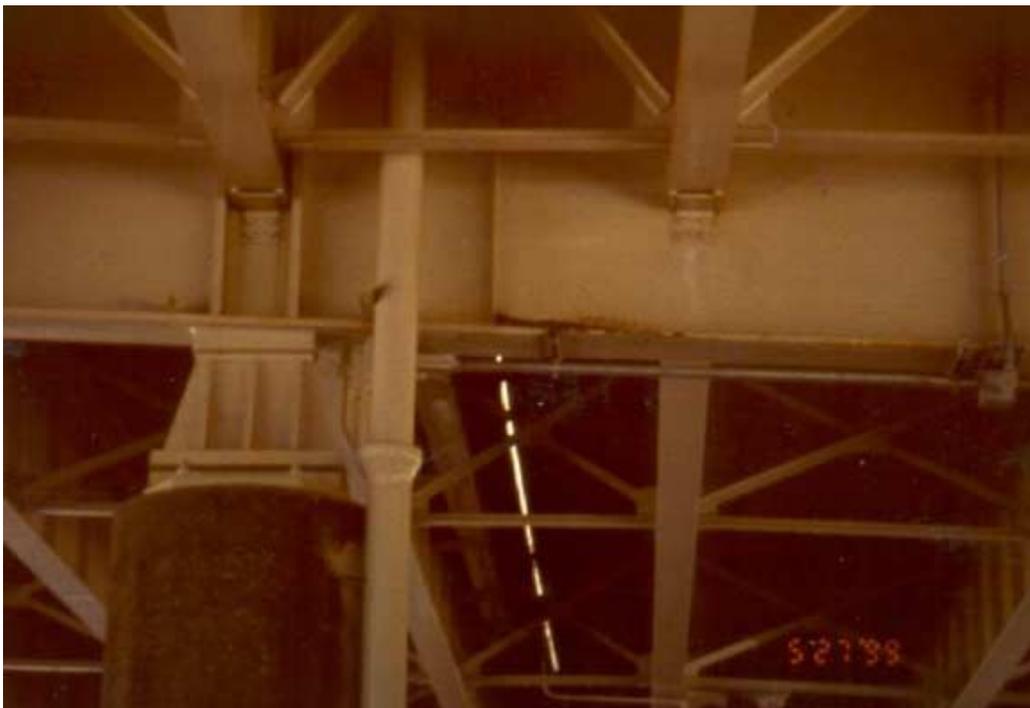
Some troughs under the open joints were filled with debris. That will cause accelerated deterioration of the paint in this area. Some rust and/or rust stains were also evident around the open troughs indicating that the design was faulty.

Figure 57. Debris build-up on lower flange of floorbeam below open deck joint in span 2 in 1999.

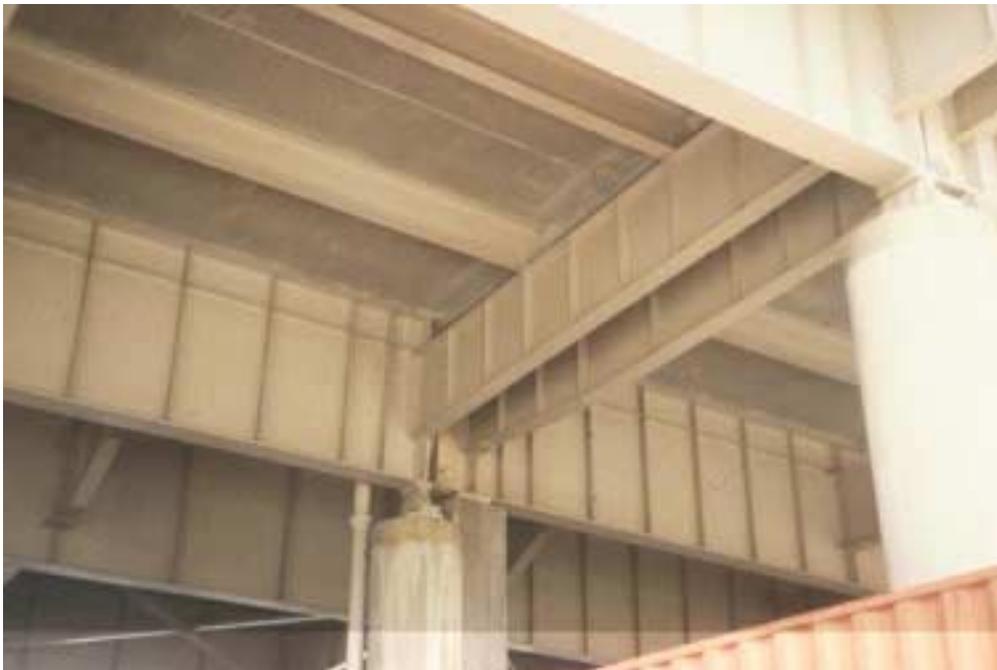
A modular joint site over the parking lot had slight rusting on the floor beam. Again, this was less than that occurring at the open deck joints in spans 1 and 2. A second modular joint where the road splits was in good condition because it was significant super-elevation of the roadway. The vertical curve there caused the water to flow away from joint. At the modular joints, through the location where span 6 enters I-64, floor beams and drains were in good condition with very little rusting. The bearings on the abutments at 9th street were in very good condition with no rust. Pinpoint rust was observed on the edges of the flanges at few spots. There were spots of missed topcoat and holidays on the stiffeners. Bolts on some diagonals were not top coated. There was no rust except at joints.

Figure 60. A modular joint in span 3 showing little signs of leakage or corrosion in 1999.

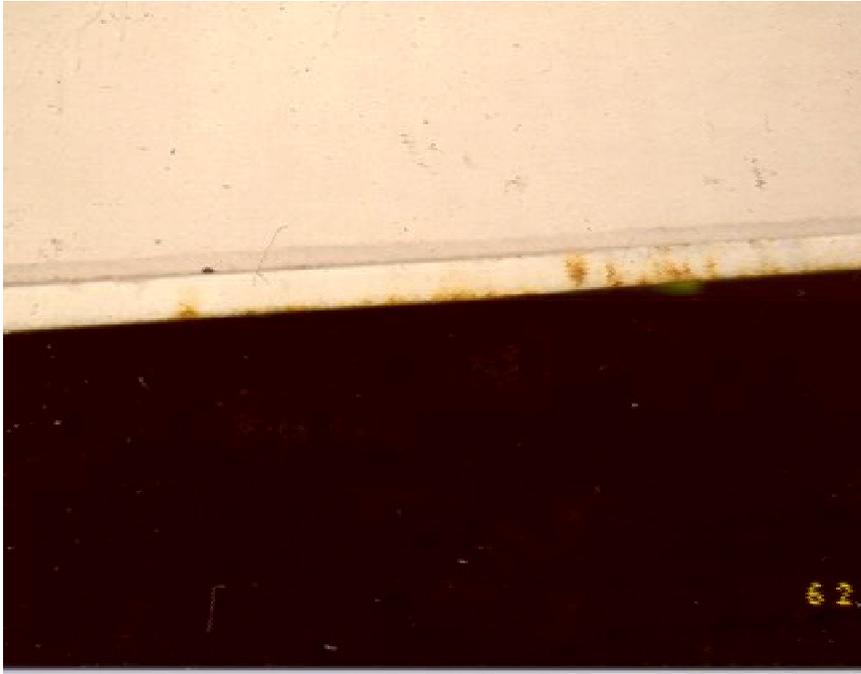
Figure 63. Rust spots observed along edges of flanges in span 3 in 1999.

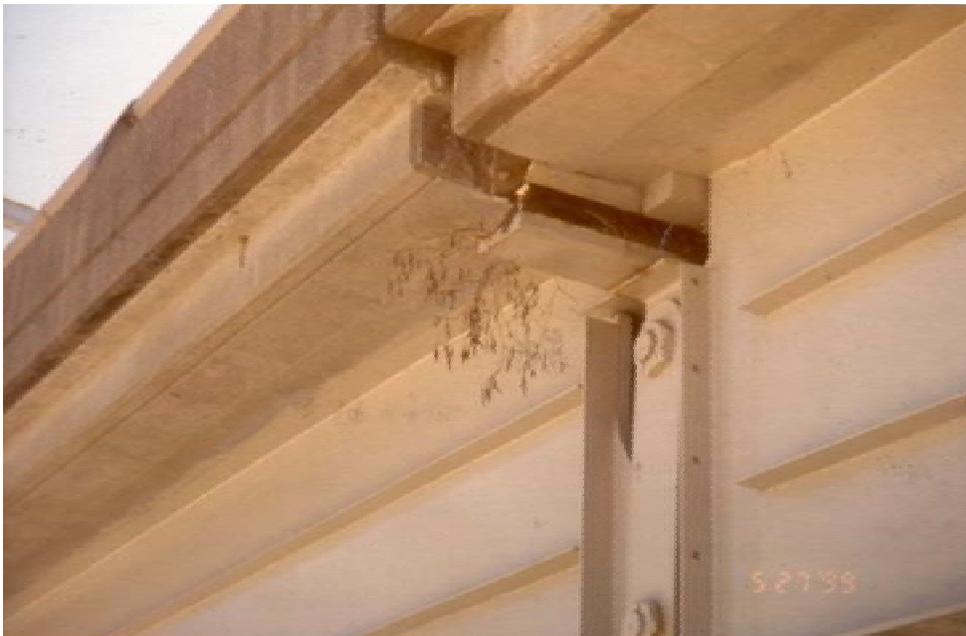
The condition of the paint was difficult to determine at the west end of Span 3. Span 3 ends over the cargo yard at 13th street. In the yard, there were a few small some spots including bolt heads where to topcoat had not been applied. There was a small amount of rust staining on the floor beams under the modular joints similar to the one observed in the parking lot. A drain on exterior of westbound lane was clogged with grass growing on it.

Figure 64. Foliage growing out of clogged drain in span 3 in 1999.

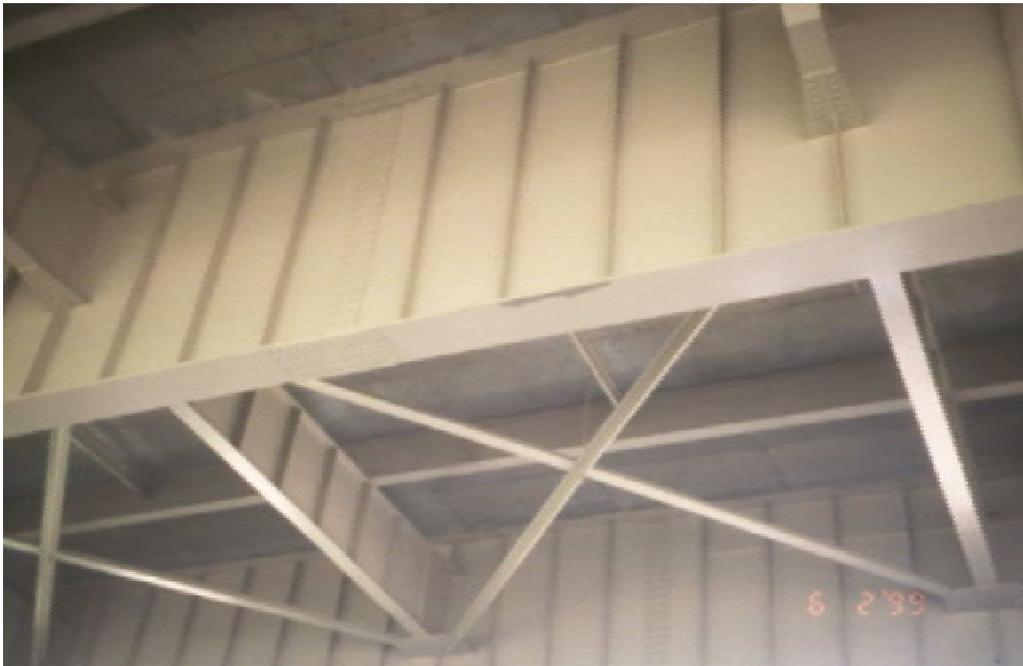
Figure 68. Span 9 over the railroad tracks showing minor disbonding in 1999.

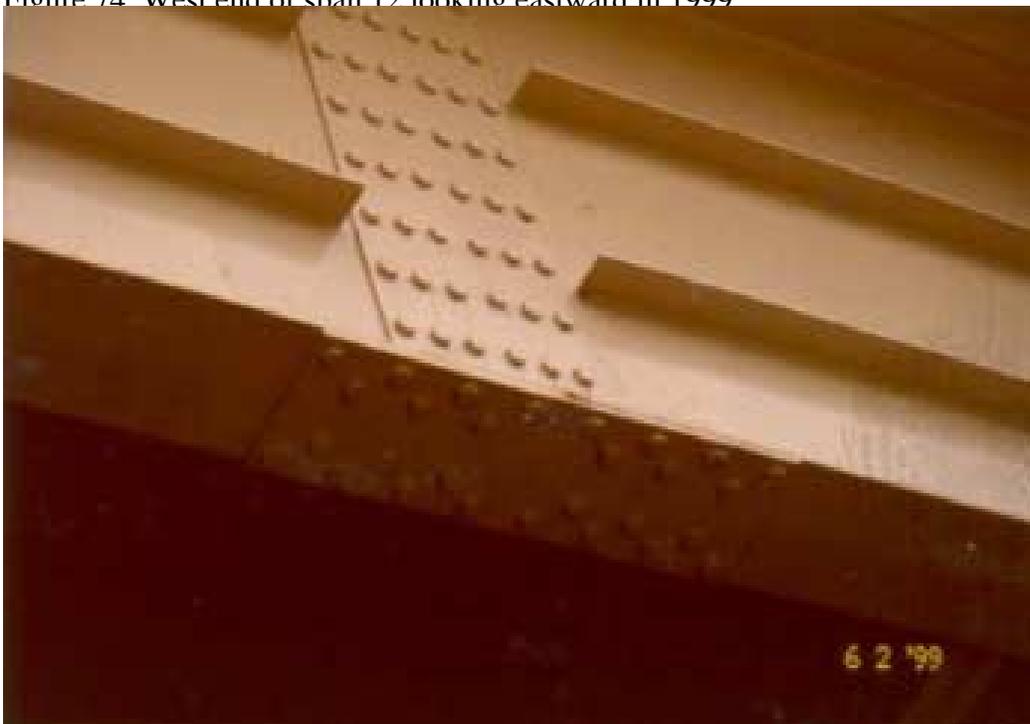
At the east end of the project, there was rust stains and corrosion on about half of the rockers and bearing plates. There was also slight corrosion on splice plates at flanges. On the first full span west of road, rust spots were found on two beams at the edge of bottom flange. There was minimal rusting at the back-to-back angles. On the second deck joint, moderate rusting was found. The drain on the fourth pier was very rusted. The deck joint on the fifth pier had rusted rockers and moderate rusting on back-to-back angles and on beams was found. The centerline longitudinal joint was leaking with minimal rust and there was medium staining on bearings and transverse steel at several piers. Transverse beams at sixth pier had minimal rust on flange edge. West abutment had rust stains with very little rust on bearings. The bulk of paint was in good condition. There were areas with missed primer on the third beam from south side. The Tooke gauge readings taken at various locations on this span are given below.

Figure 75. Slight corrosion at splice plate in span 12 in 1999.

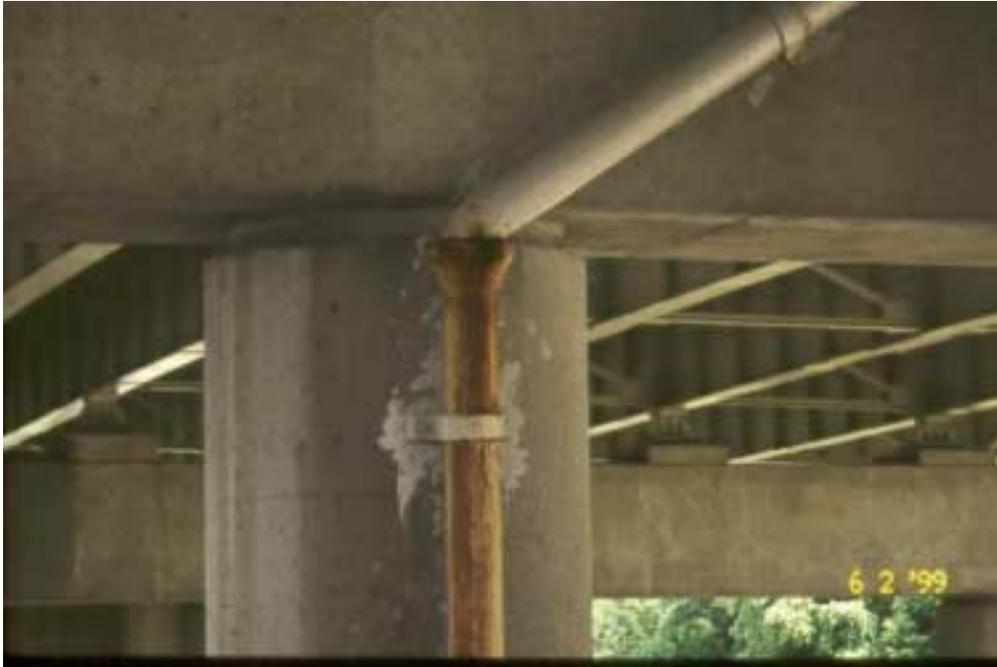
Figure 76. A clogged drain at the west segment of span 13 in 1999.

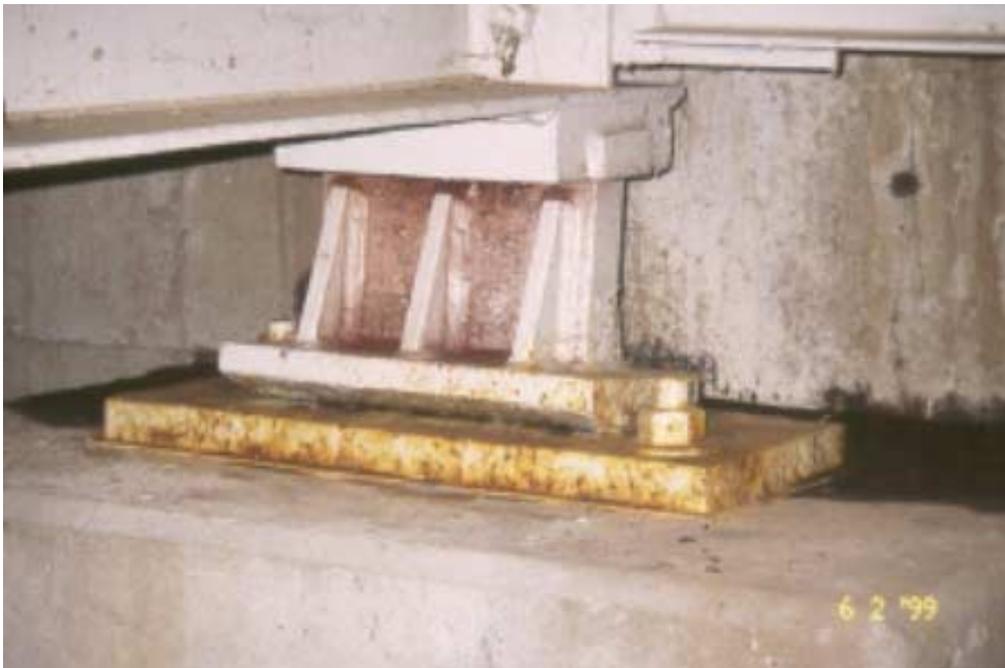
Figure 77. Corrosion and rust staining on rocker and bearing plate in span 13 in 1999.

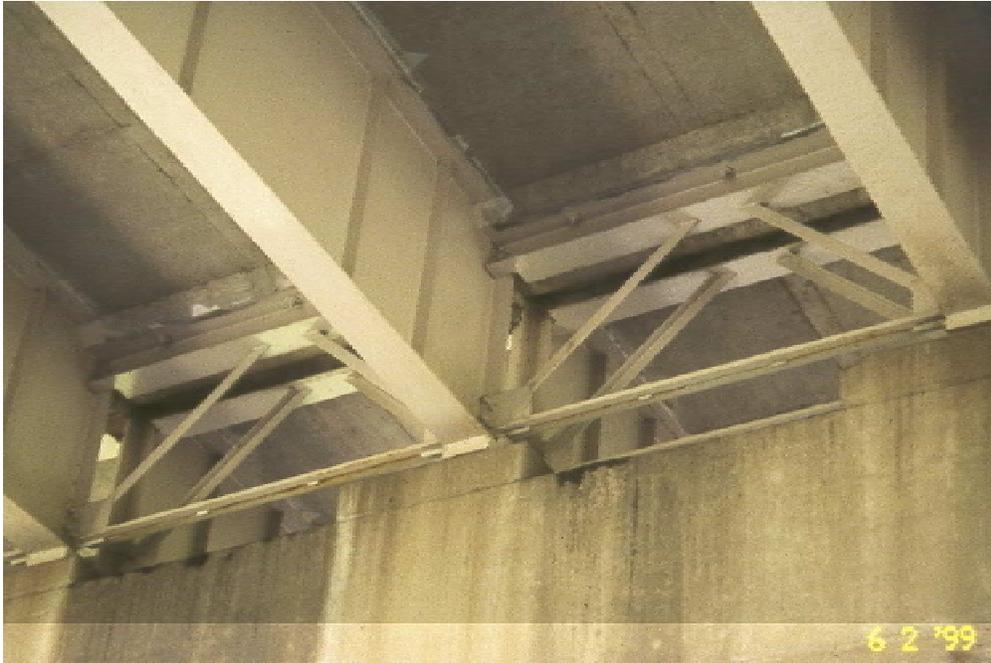
On the second deck joint from the east end, there was rust on the trough, beams and cross bracing. Also there was spot rusting on center of flanges. On the second deck joint east of the railroad there was moderate rust under an open deck joint. On the first deck joint east of the railroad there was moderate rust along the joint. There was rust stain at the deck joint, just west of railroad on beam-ends and cross bearings. There were diesel stains on beams over railroad track. There was rust at all the deck joints west of the railroad. There was minor spot rusting on the edge of some beam flanges along the span. On the west segment of span 13, there was rust on a drainpipe at location where the pipe had obviously clogged. There was extensive graffiti at the west abutment. That abutment was at ground level and readily accessible to trespassers. The bearings on west abutment were rusted. Tooke gauge readings taken at various locations on west-most span are given below.

Figure 78. Corrosion in back-to-back angles under deck joint in span 13 in 1999.

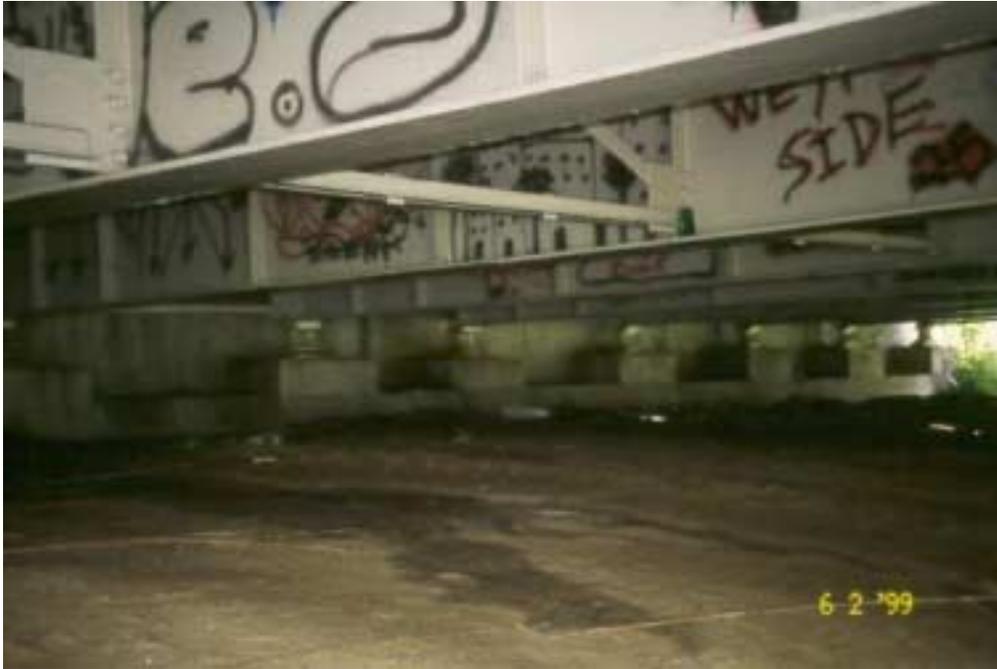
Figure 80. West most abutment of span 13 showing extensive graffiti in 1999.
